July 17, 2024

RE: Greenwood Park - MaryMiss Double Site

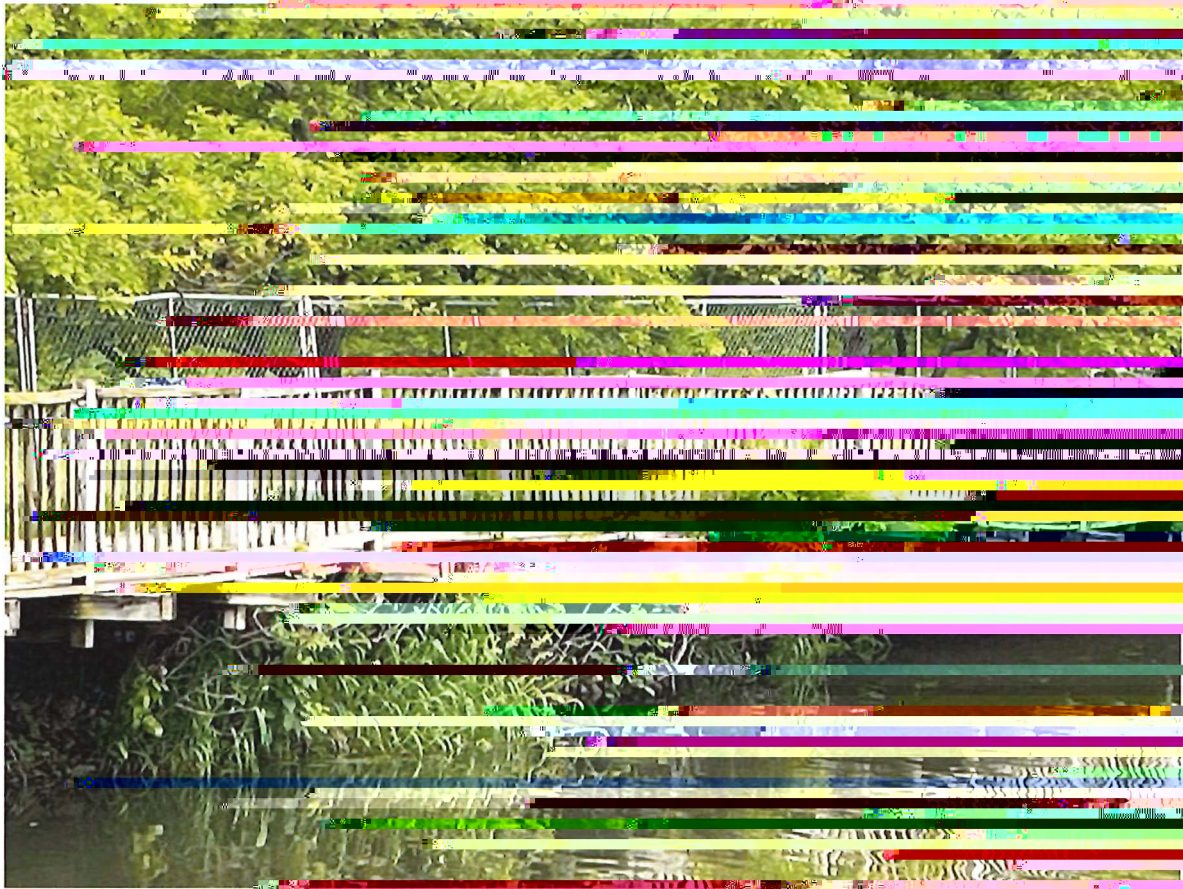
3. Structural instability

- a. Due to the severe wood decay the boardwalk floor framing is missing boards and the wood framingsystem that holding up the boardwalk has lost its design strength and appears to not be able to handle the weight of people walking on top of it
- b. The wood decay has also caused obvious signs of heaving and buckling in the framing system making the system structurally unstable.
